# Farmville, Virginia Historic Design Guidelines

# FARMVILLE — DOWNTOWN — PARTNERSHIP

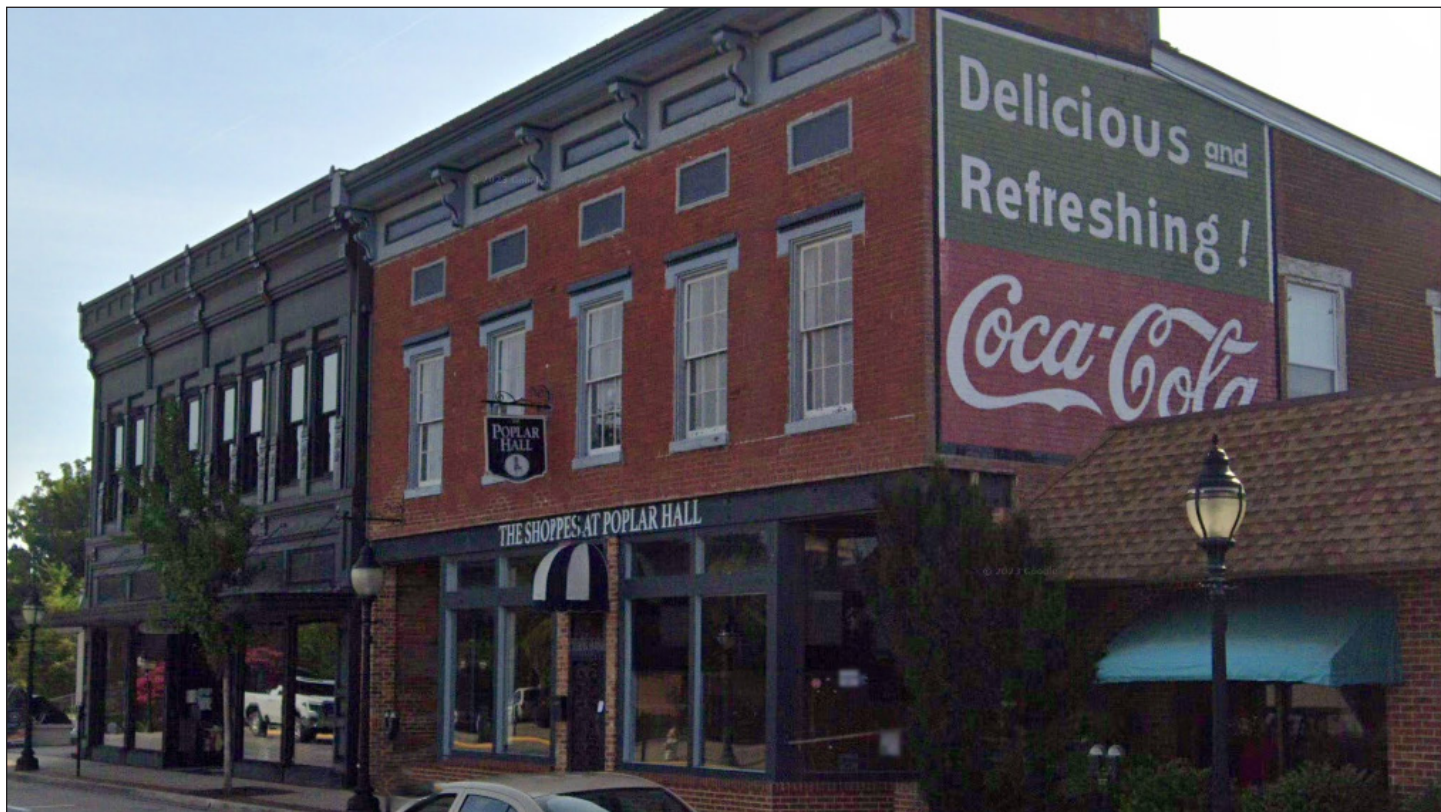
Figure 3: 308 N. Main St.

A noteworthy example of Greek Revival era design is the J.H. Whitfield Company building, situated at 308 North Main Street. Constructed circa 1840, this two-story structure incorporates distinct Greek Revival features; notable features include the uniquely-preserved decorative recessed rectangular panels above each window, as well as the ornate window heads. Additionally, the building boasts a bracketed cornice that spans the top of the storefront, adding a touch of architectural flair that speaks to the evolving styles of that era.

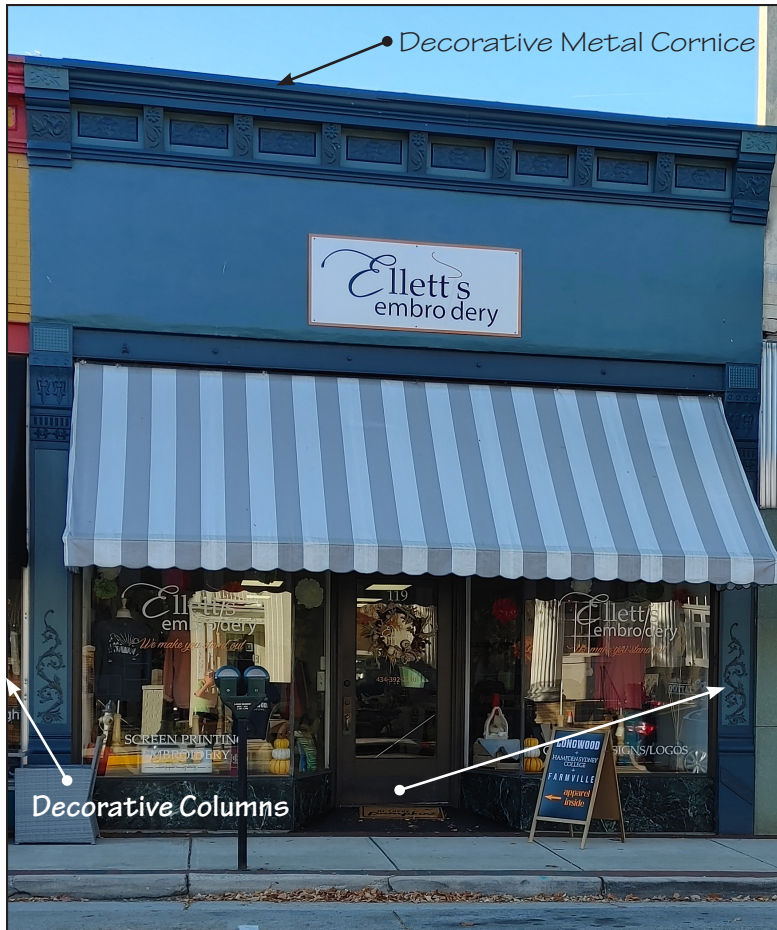
Figure 4: 119 N. Main St.

Although the style originated from England in the early 19th century, the Victorian Italianate style also became popular in the United States after the Civil War. An example of this style can be found in the Doyne Building, located on 114 North Main Street. The Doyne Building is Farmville’s first mortuary; Constructed in 1887, it embodies the Victorian Italianate architectural trends of the time, with an array of brick colors, segmented arched brick window heads, cast metal bracketed cornices, and storefronts constructed of cast metal pilasters. A few key elements of this style are: tall narrow rectangular or arched windows, entrances with decorative details (such as columns and brackets) single or double doors, bay windows, mass-produced cast iron or pressed metal decorative elements, and deep overhanging eaves with prominent decorative brackets and wide cornices. Other examples of historic buildings in Farmville that embody this style are displayed above.

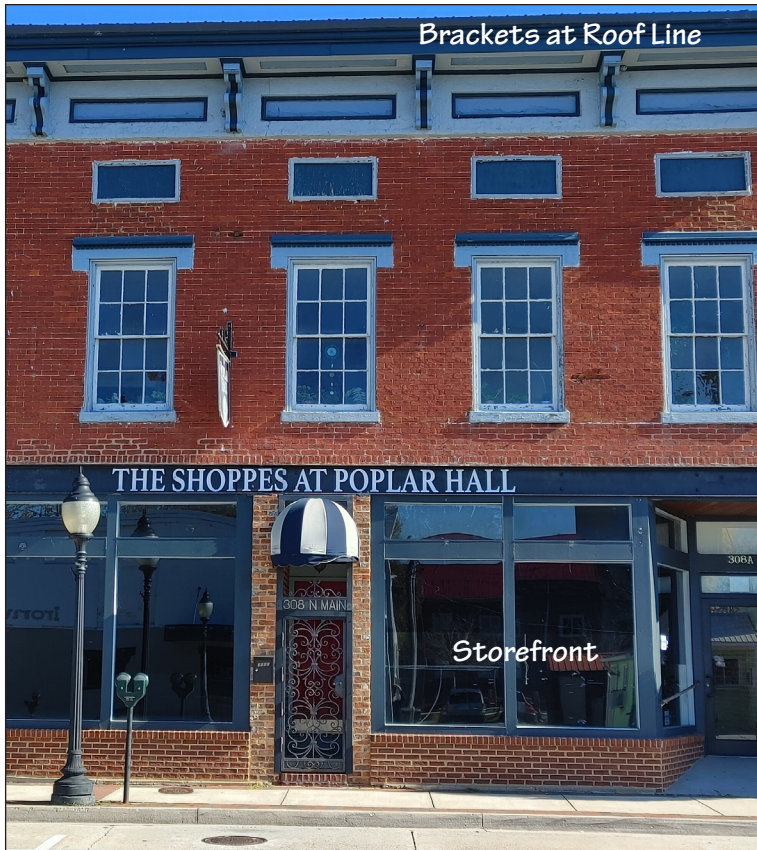
Figure 8: 308 N Main St.

The Greek Revival style became prevalent in the United States during the late 18th century, with its influence persisting into the mid-1900s. Inspired by the democratic ideals of ancient Greece, this architectural movement reflected a profound admiration of classical Greek design elements and sought to evoke a sense of grandeur and civic virtue. Characterized by its symmetrical facades, prominent columns, and pediments, Greek Revival structures often featured Doric, Ionic, or Corinthian columns supporting a pediment adorned with classical motifs. An example of this popular style is the J.H. Whitfield Company, located at 308 North Main Street.

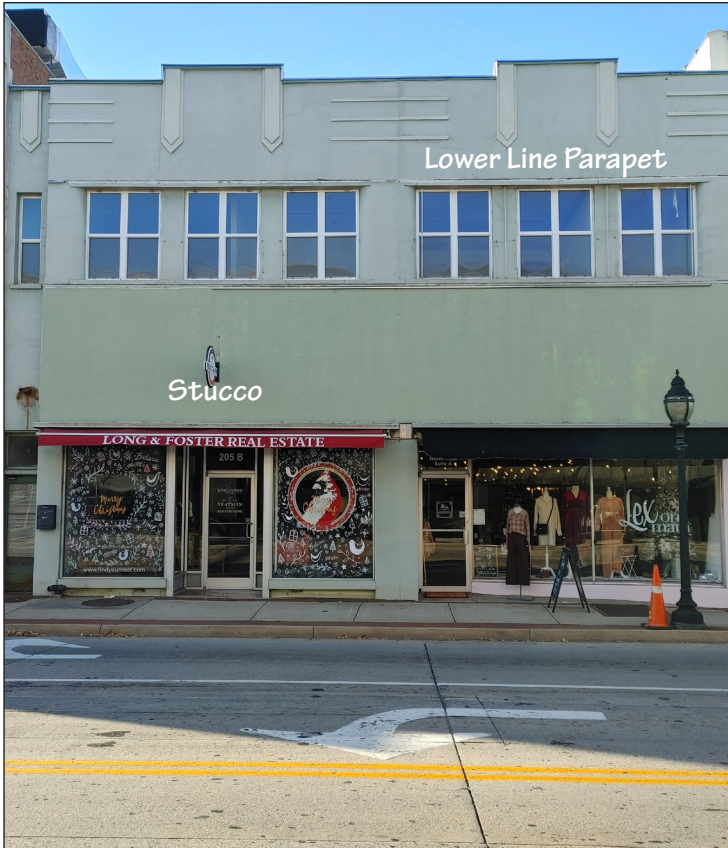
Figure 10: 205 N. Main St.

Art Deco was a short-lived but popular architectural style during the 1920s. A few characteristics of this style are materials such as stucco, terracotta and decorative glass, geometric shapes, bright and contrasting colors, and parapets that resemble towers. Art deco is non-traditional to Farmville, but can be spotted on a few buildings throughout the historic district. 205 North Main Street is an example of a commercial building with art deco features. The building's exterior is stucco with geometric features at the two parapets.

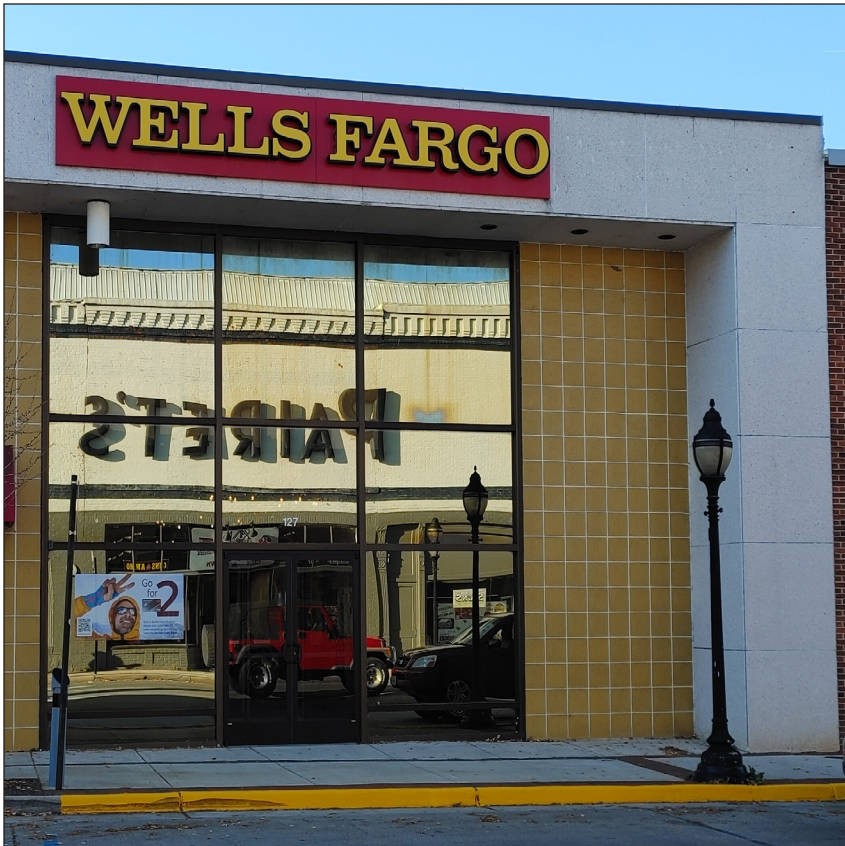
Figure 12: 127 N. Main St.

Farmville's modern architecture has seamlessly woven itself into the town's historic fabric, presenting a juxtaposition of tradition and innovation. Characterized by clean lines, geometric shapes, and a focus on functionality, modern structures in Farmville embody a progressive spirit while respecting the town's historic building pattern. 127 N. Main St and 201 N. Main St. are examples of some of Farmville's modern buildings, featuring tall storefront glass simplistic and colorful designs. Additionally, the incorporation of sustainable building practices and energy-efficient technologies in modern constructions reflects the Farmville's community's pursuit of a "greener" future. As the Town evolves, modern architecture serves not only as a testament to contemporary design principles but also as a dynamic dialogue between past and present, enriching the architectural tapestry of Farmville.

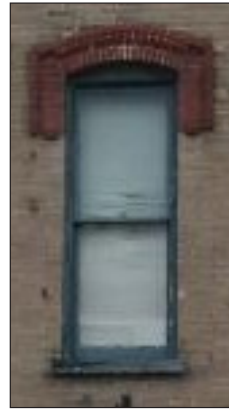
Figure 14: Single Hung, The Doyne Building

Historic wood windows are of better quality than today's wood framed windows, as historic wood has better resistance to water and insect damage and saves energy costs if repaired properly. It is best practice to rehabilitate and repair historic wood windows in lieu of replacing.

In the event that a historic wood window cannot be repaired, replacing it with another wood framed window is acceptable. All replacements must be done with moisture-reduced and/or wood-resin composite wood. New windows should match the original design and dimensions.

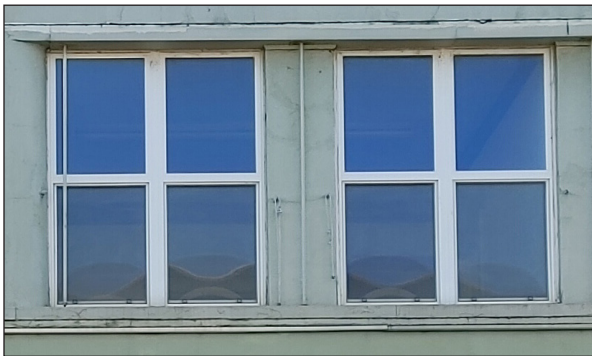
Figure 16: Metal Windows, 205 North Main St.

Like wooden windows, metal framed windows can be rehabilitated or repaired. Signs that a metal framed window should be rehabilitated include severely chipped paint, cracked glass, split masonry, lifting of putty around glazing, and corroded metal. (Typically identifiable by warped, jammed or failing frames.)

**Repair:** To repair metal framed windows, it is best practice to use a dent straightening technique, cold stitching, and modern welding. For chipped paint, a micro abrasive cleaning solution is recommended.

**Replace:** It is acceptable to replace metal-framed windows if they display irreparable damage. When replacing the window, it is best practice to keep the same window style with respect to the historic character and dimensions of the original. The new window should fit tightly within the existing opening without sub-frames or panning.

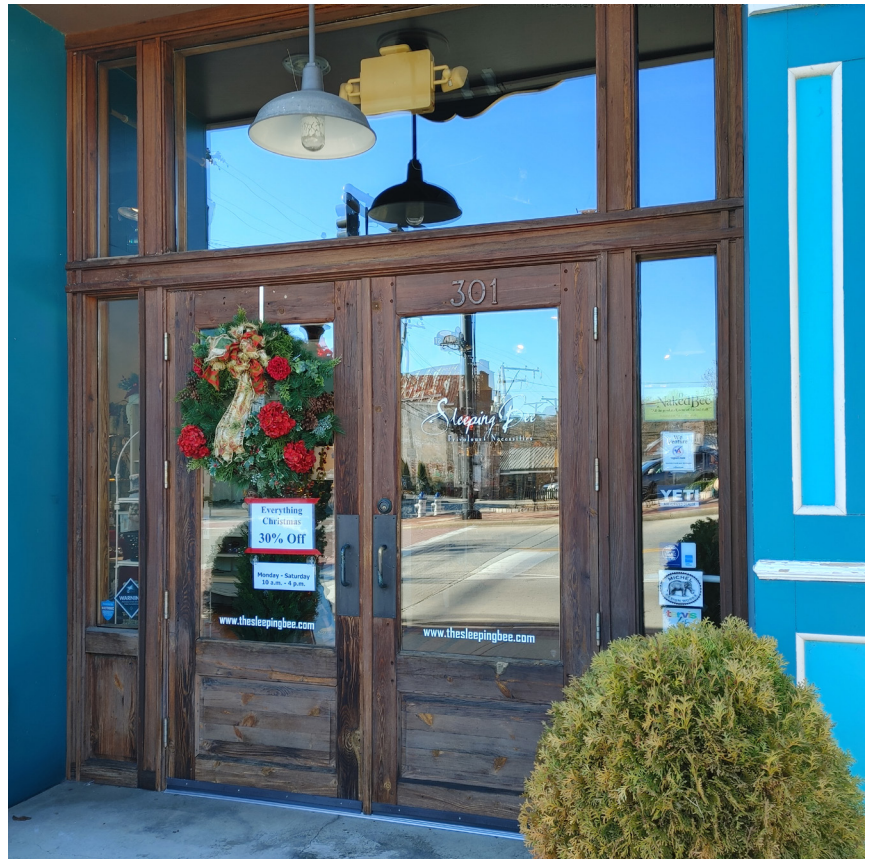
Figure 19: Double Wooden Door with side panels and transom.

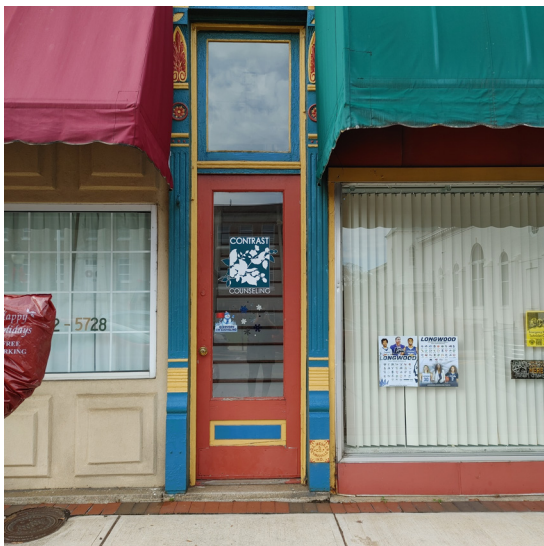
Figure 18: Decorative wooden door with transom

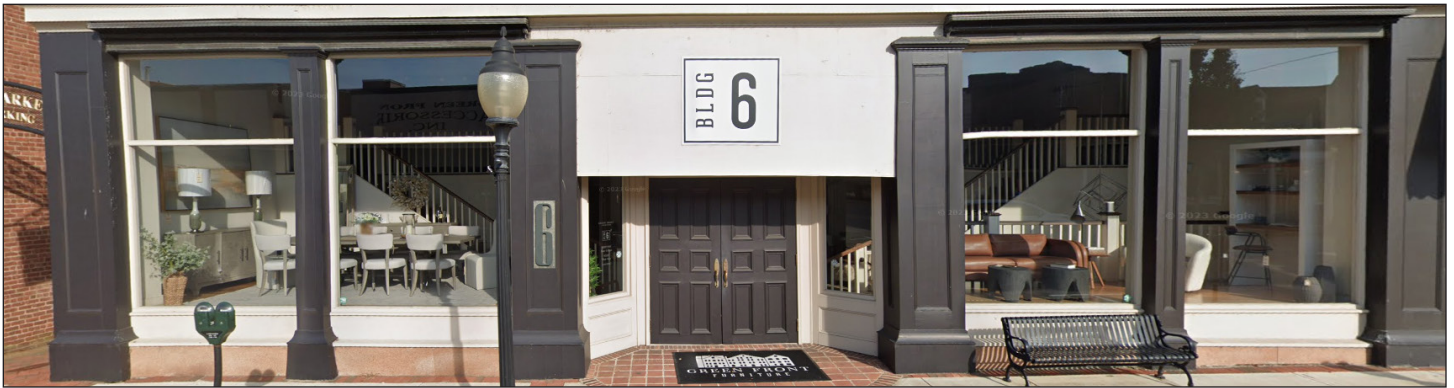
Figure 20: Building 6 Storefront

The storefront of a historic commercial building is one of the most significant parts of its facade. Transparent windows are designed to draw customers into the business as well as to display the merchandise sold there. At night, the lit storefront illuminates the sidewalk and adds visual interest for downtown visitors. Many of the traditional storefronts in Farmville’s downtown historic district date from the late 19th century.

**Repair:** Preserve the original storefront whenever possible. When maintaining or restoring a storefront, special attention must go towards repairing missing elements, such as cornices, window frames, and transoms.

**Replace:** If storefront must be replaced, keep the original size and material. If elements are damaged beyond repair, replace them with simplified elements that are in alignment with the character, design, and materials of the existing building. For more information: [Storefronts](#), [Substitute Materials](#), [Awnings](#).

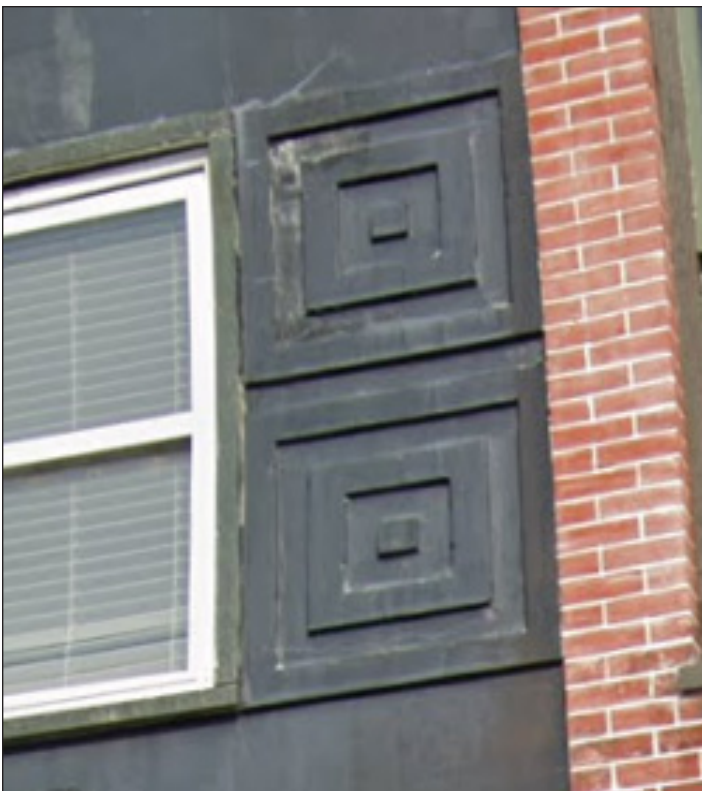
Figure 22: 233 N. Main St. Detail

**Historic architectural detailing should be maintained and preserved.**

**Repair:** Historic architectural detailing should be maintained and preserved.

**Replace:** If the detailing is deteriorated beyond repair, it should be duplicated using historic building materials. Using a substitute that matches the historic composition, design, color, texture, and other visual qualities is also acceptable. Any missing details should match the historic materials as closely as possible.

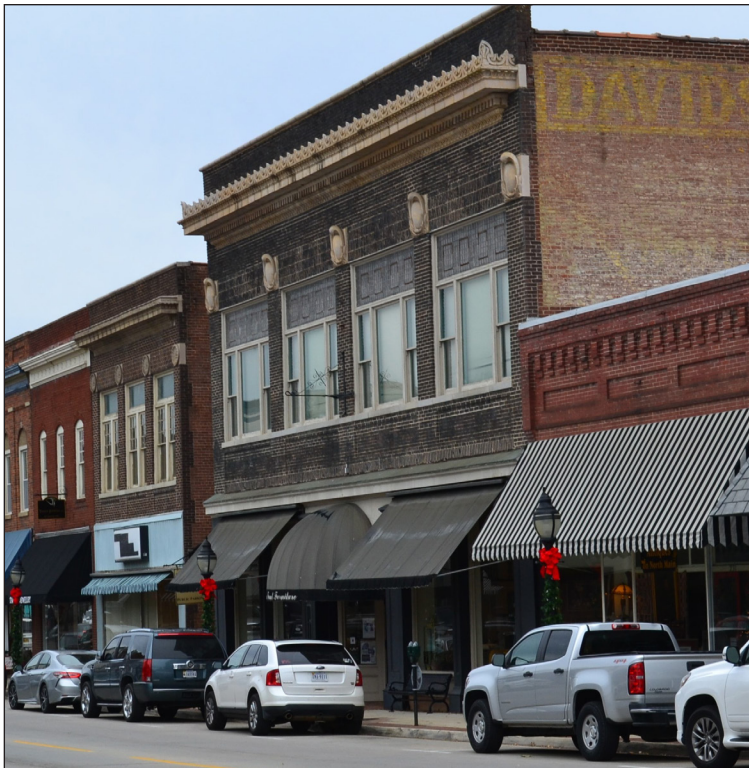
Cornices are located at the junction between the roof and the wall and are typically made of galvanized metal.

A parapet is a low, protective wall at the edge of a terrace, balcony, or roof, especially that part of an exterior wall, fire wall, or party wall that rises above a roof. These elements may be an extension of the material and design of the wall, or they may be a separate design. They are often a decorative feature and may be made of brick, stone, cast stone, wood, or metal.

Figure 25: Davidson Building, 229 N. Main St. Cornice and Parapet detail

Repair/Replace: Removing cornices or parapet elements are not recommended, especially if they are aspects of the original design. If the original trim must be replaced, the materials used should not convey a different period of construction or architectural style.
